Electrical Preventive Maintenance Pays Off!

A case study on controlling risks to plant & profits

Joe Gierlach ~ Director, Technical Training and Support
TEGG Corporation ~ Pittsburgh, PA

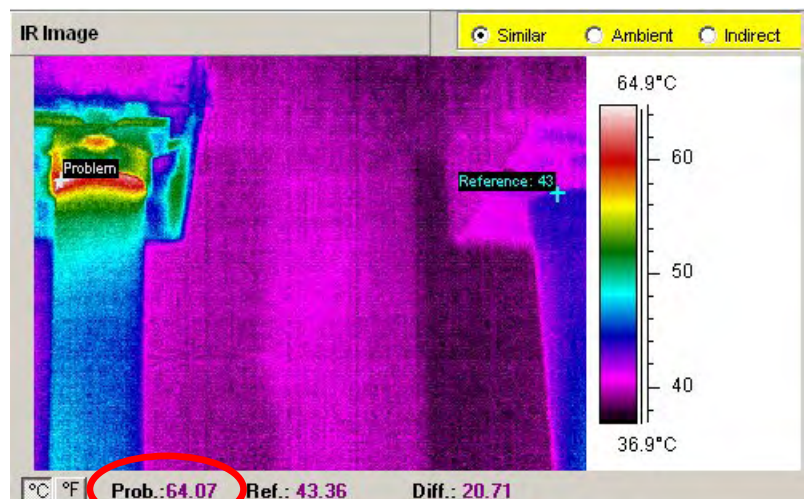
Figure #3

DenHartigh identified the line side of the "B" Phase 14.4 KV, 200-amp fuse as the area of interest. At this time (second week of service), the spot temperature of the fuse displayed 64°C (147°F) on the infrared camera. The source of the temperature was oxidized aluminum, and it is important to note that the initial temperature calculation was *uncompensated* and did not correct for the low Emissivity of the target. Emissivity represents the efficiency at which an object emits infrared radiation; infrared radiation is what an infrared imager or "camera" detects and uses to calculate temperatures. The less efficiently an object emits radiation, the lower the temperature would appear to the camera (if the object is at a higher temperature than the reflected background radiation).

The area of concern on the top of the fuse is clearly visible in Figure #3. This image was taken through a VPFR

infrared window with the camera's parameters properly configured to compensate for the external optics (including Transmissive properties of the window and window temperature). The problem temperature ("Prob" on the screen shot) is indicating 64°C (147°F) with the Emissivity set at .96 which is characterized as "uncompensated." The anomaly was identified and documented as an area of concern to be monitored for signs of deterioration.

Knowing that this clamp is manufactured with a material that is NOT efficient at emitting radiation (only about a .5 efficiency), the technicians were aware that a camera adjustment was necessary in order to obtain more accurate temperature information. Once this adjustment was made, the 64°C (147°F) temperature was corrected to reflect a more accurate temperature to 107° C (224.6°F), illustrating an error of over 40°C (104°F). These findings prompted the service provider to more closely monitor the fuse clamp; monitoring intervals for this switch were changed to weekly surveys.

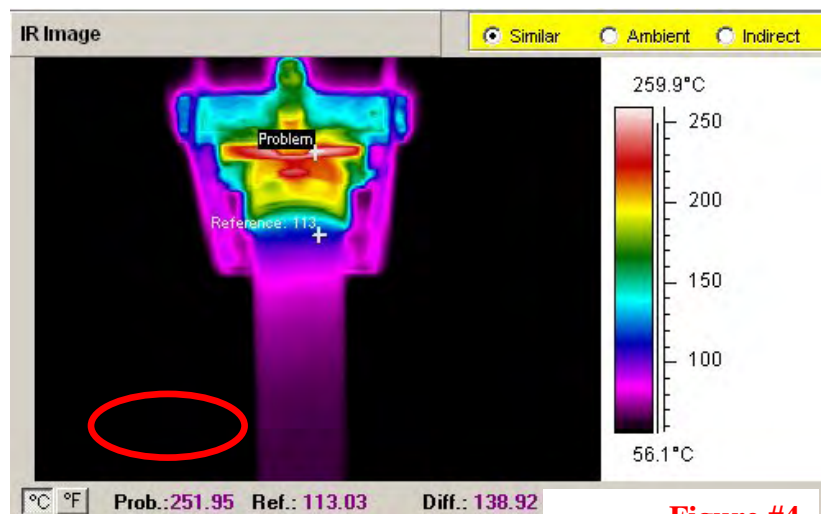
As Figure #4 demonstrates, the result of this survey proved to be far more alarming than the initial survey: The problem temperature had increased to 252°C (486°F) in just ten days since first identified. The new temperature represented an increase over 300%, indicating a significant and accelerated deterioration of the assembly.

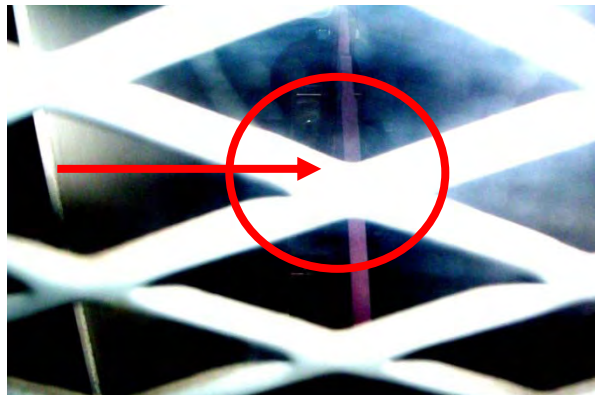
Figure #6

conduction from the top. To make matters even more pressing, the Plexiglas window above allowed for a visual inspection that revealed the connection was in fact luminescent at this point (as seen in a digital photo in Figure #6). Based on the material and color visible, the actual temperature was calculated at nearly 850°C!

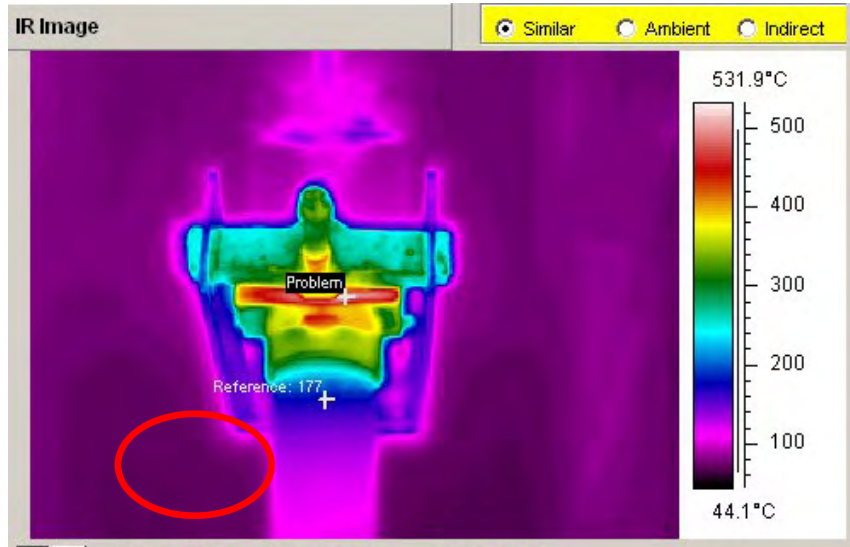
Figure #5

When proper Emissivity was compensated for (Figure #5) the results were more alarming.

The extent of the fuse deterioration became crystal clear. The actual temperature was not simply 252°C (486°F); it was in fact almost 508°C (946°F). Also noteworthy is the fact that the angle of view from the IR window did not allow for a direct line to the source of the heat, which was on the top portion. The temperature observed was visible through

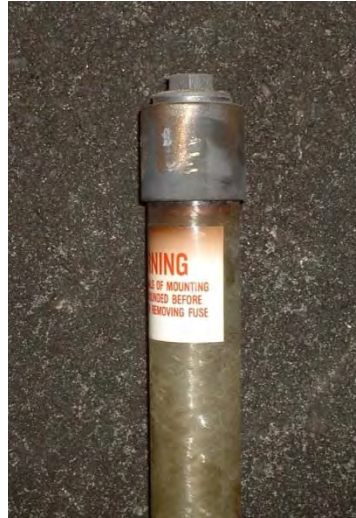
Figure #7

The Autopsy: It was evident upon inspection that the original suspicions and analysis were on the mark. The results of the extreme temperatures that these components were exposed to are clearly visible. The fuse itself was visually discolored from the heat damage (Figure #7), and the clamp assembly was

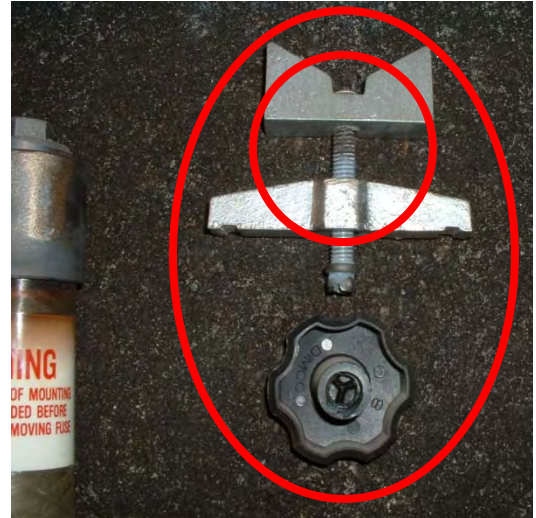
Figure #8

burnt and gaulded. The plastic tightening knob was melted off its mount (Figure #8) and was found lying on the bottom of the enclosure.

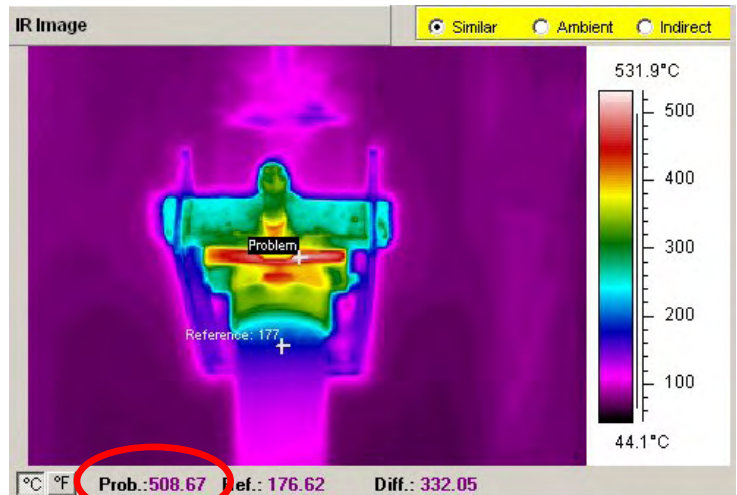
Overheated Fuse clip clearly evident

Let's compare the before and after images (both compensated for Emissivity). Figure #9 clearly shows the overheating of the fuse clip.

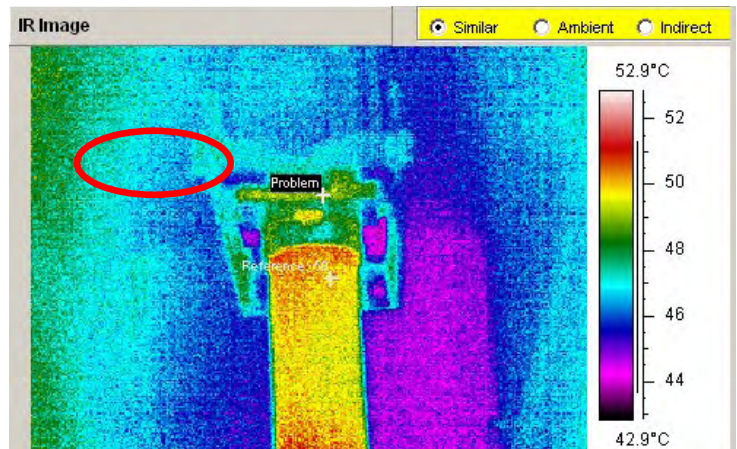
Figure #10

A subsequent IR scan (Figure #10) through the newly installed window revealed evenly distributed operating temperatures of approximately 49°C (120°F) on all three fuses – representative of what one would expect to view on this type of equipment and load demand conditions in a “normal state.”

After repairs were made the temperatures are moderated
