Electrical Preventive Maintenance Pays Off!

A case study on controlling risks to plant & profits

Joe Gierlach ~ Director, Technical Training and Support
TEGG Corporation ~ Pittsburgh, PA

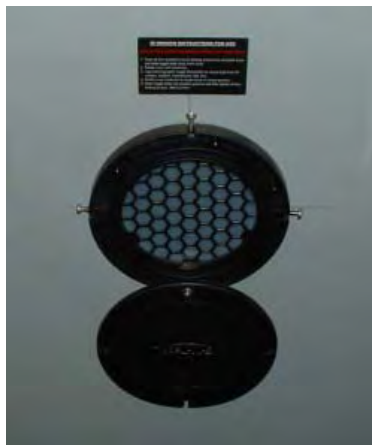
Figure #1

IRISS VPFR IR Window

The first phase of implementing the program was to install the 40 IRISS VPFR infrared windows (as seen in Figure #1) during the scheduled maintenance shutdown on July first at Bradford White. A crew of 11 technicians completed the installations and performed cleaning and housekeeping tasks on the high-voltage equipment at that time.

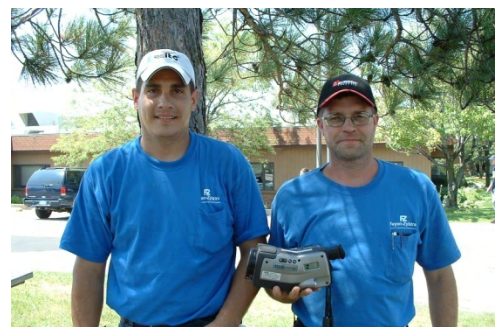
Figure #2

Mark DenHartigh & Bruce Boer

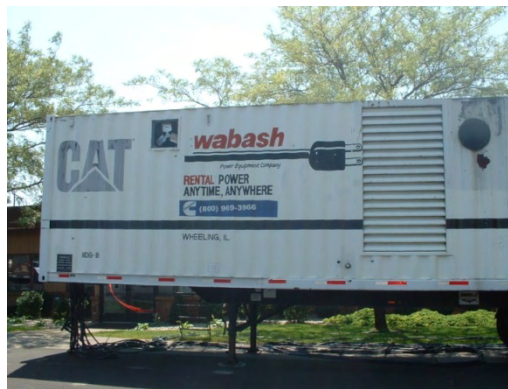
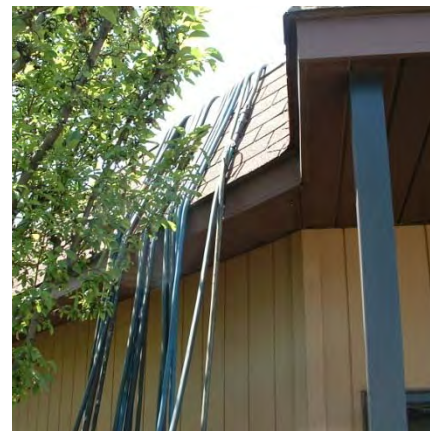
8:45 pm: The generator and cabling were on site, and with a crew of eight technicians from Feyen-Zylstra, the process of “stringing” the cable runs had begun.

3:45 pm: Mr. Potter elected option number three and issued the authorization to initiate the plan and correct the problem. Phone calls immediately began to companies in the local area that could supply a portable generator and wiring large enough to support the production demand. A 2 MW generator was needed based on the capacity of the facility. Additionally, 18 runs of cable 200 feet long were needed to temporarily run power from the generator to the switchgear lineup.

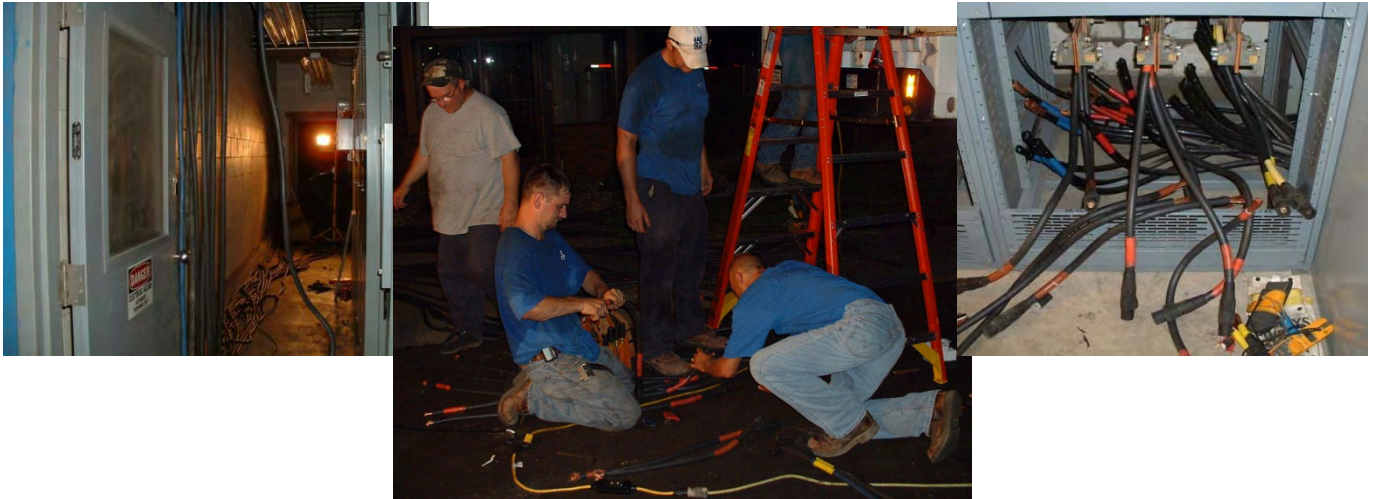
10:30 pm: The cables were in place, and the task of connecting all the cables on both ends was initiated.

The technicians feverishly worked to have the generator on line by the 12:00 AM time frame outlined by Mr. Potter to ensure that the midnight shift workers would be able to complete a full production effort.

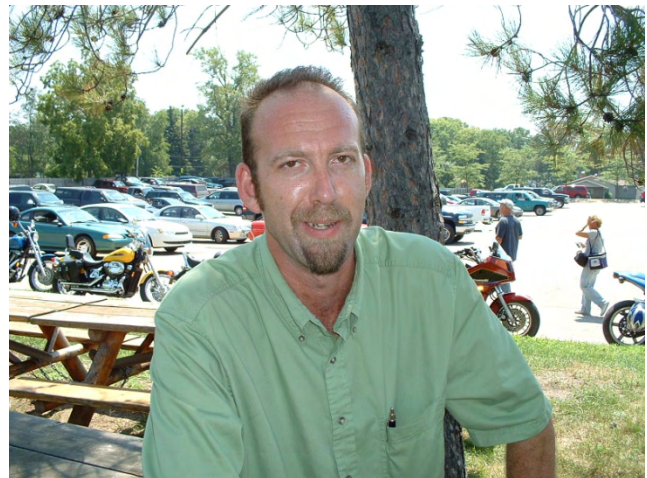
Craig Potter,
Bradford White Facility Electrical Engineer
